TRANSPORTATION RESEARCH CENTER

**ON-SITE SCHOOL BUS INVESTIGATION**

CASE NO. - 95-22  
FLEET - CORPORATE SCHOOL BUS  
LOCATION -  
ACCIDENT DATE - 1995

Contract Number: DTNH22-94-D-17058

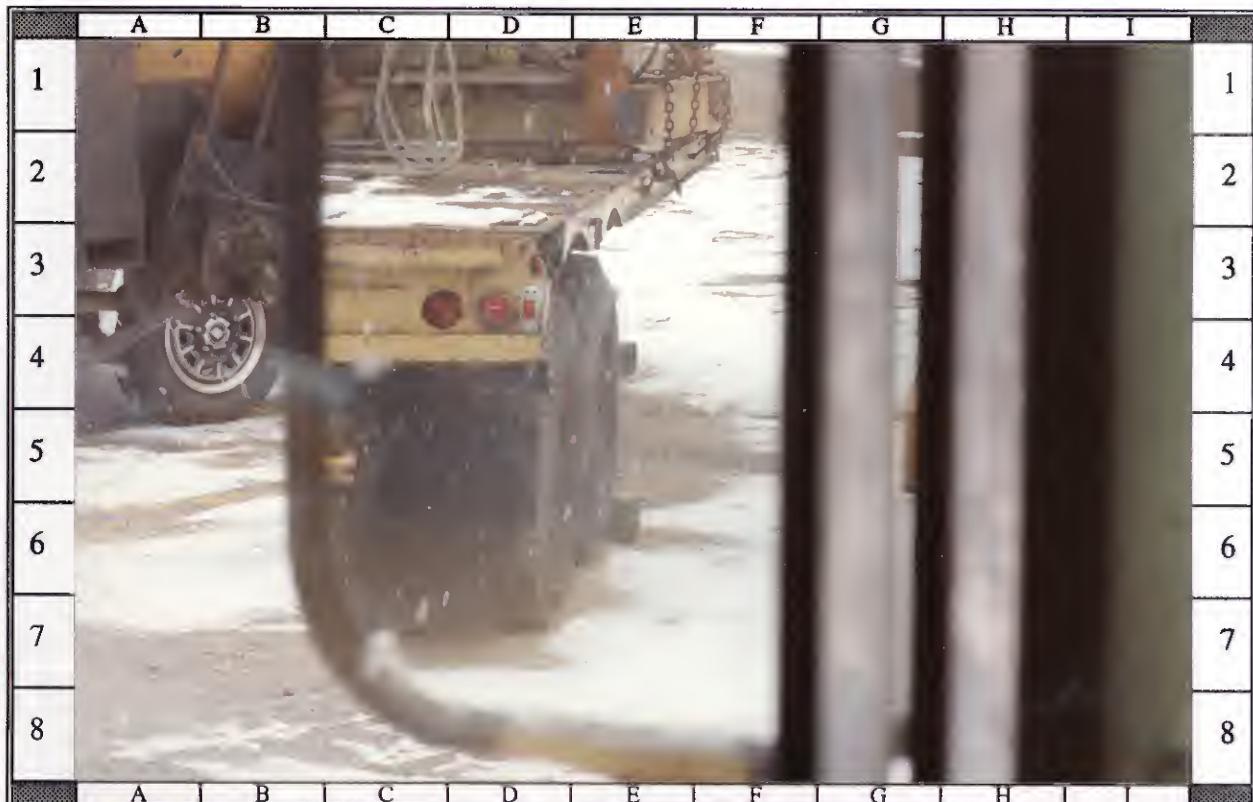
# 28: Telephoto view from Case Vehicle's driver seat through left, outside, unit magnification mirror; NOTE: test cones L and M are not visible

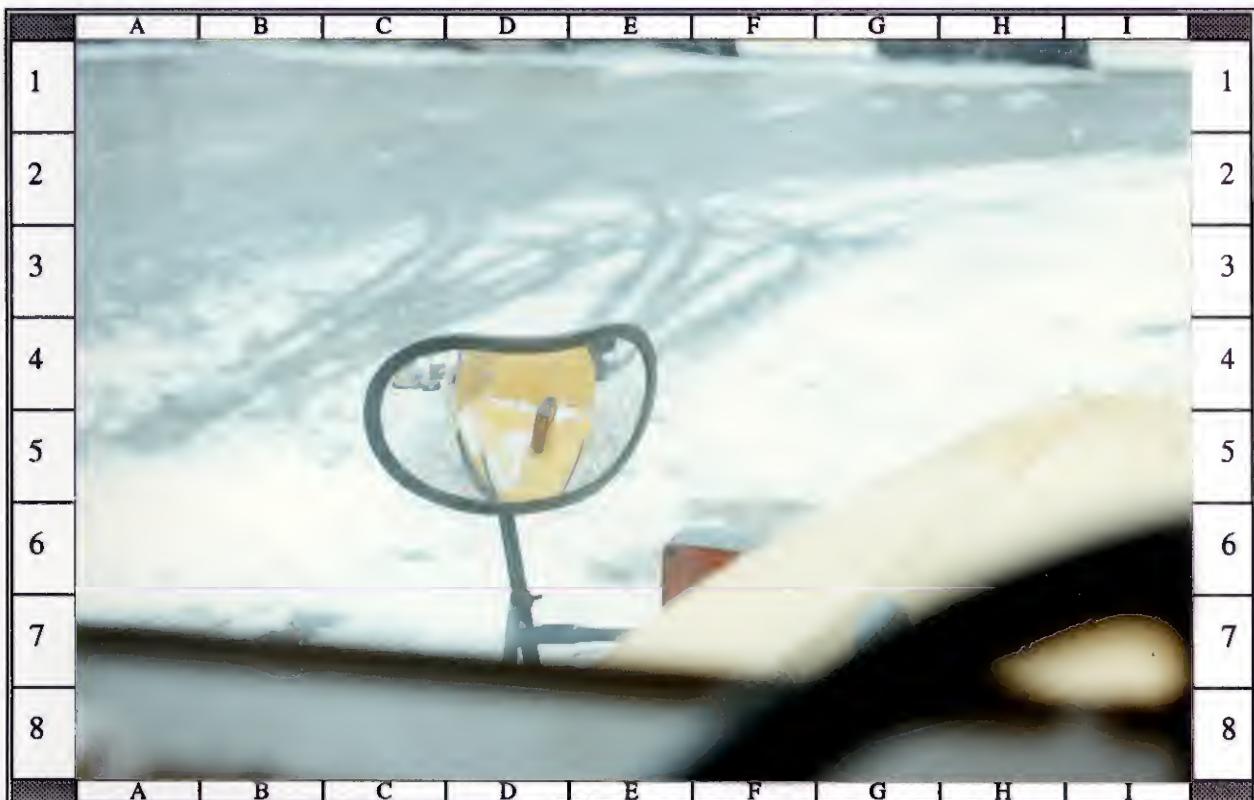
# 29: Normal view from Case Vehicle's driver seat through left, outside, convex, cross-view mirror

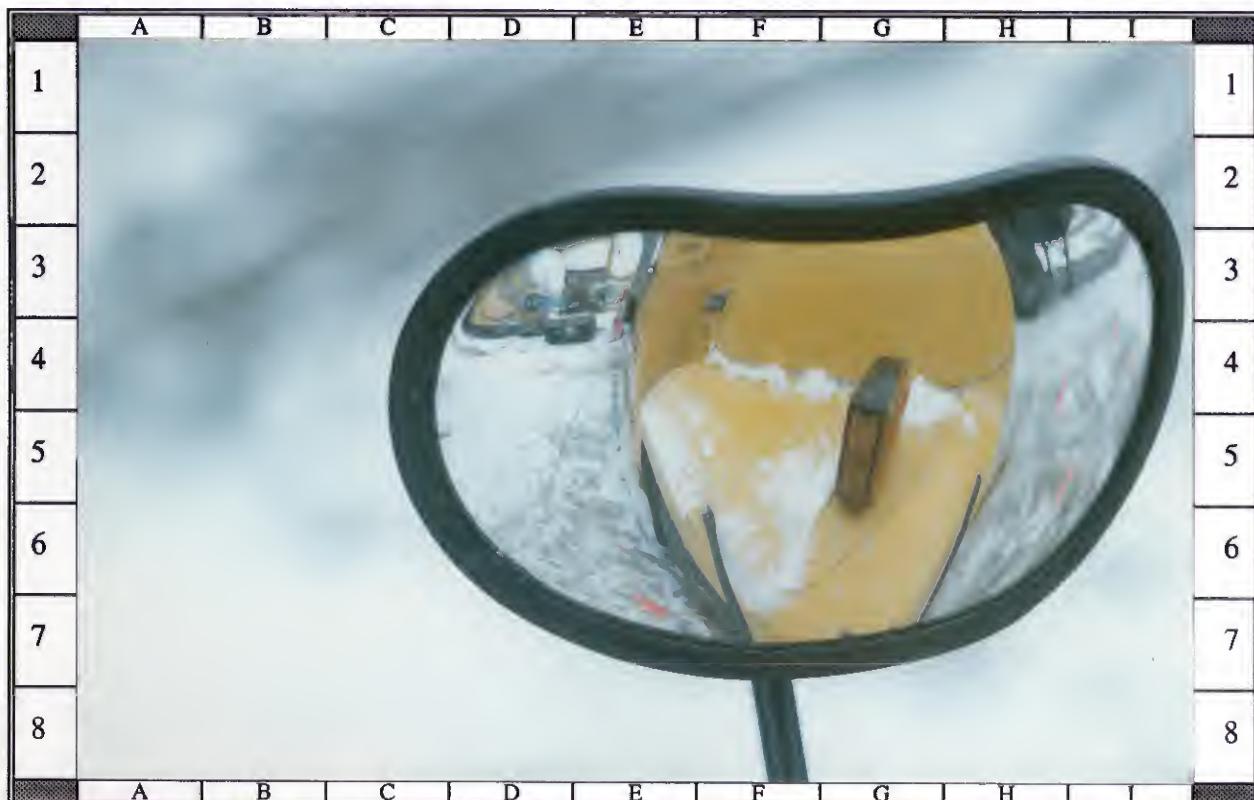
# 31: Telephoto view from Case Vehicle's driver seat through left, outside, convex, crossview mirror focusing down left side

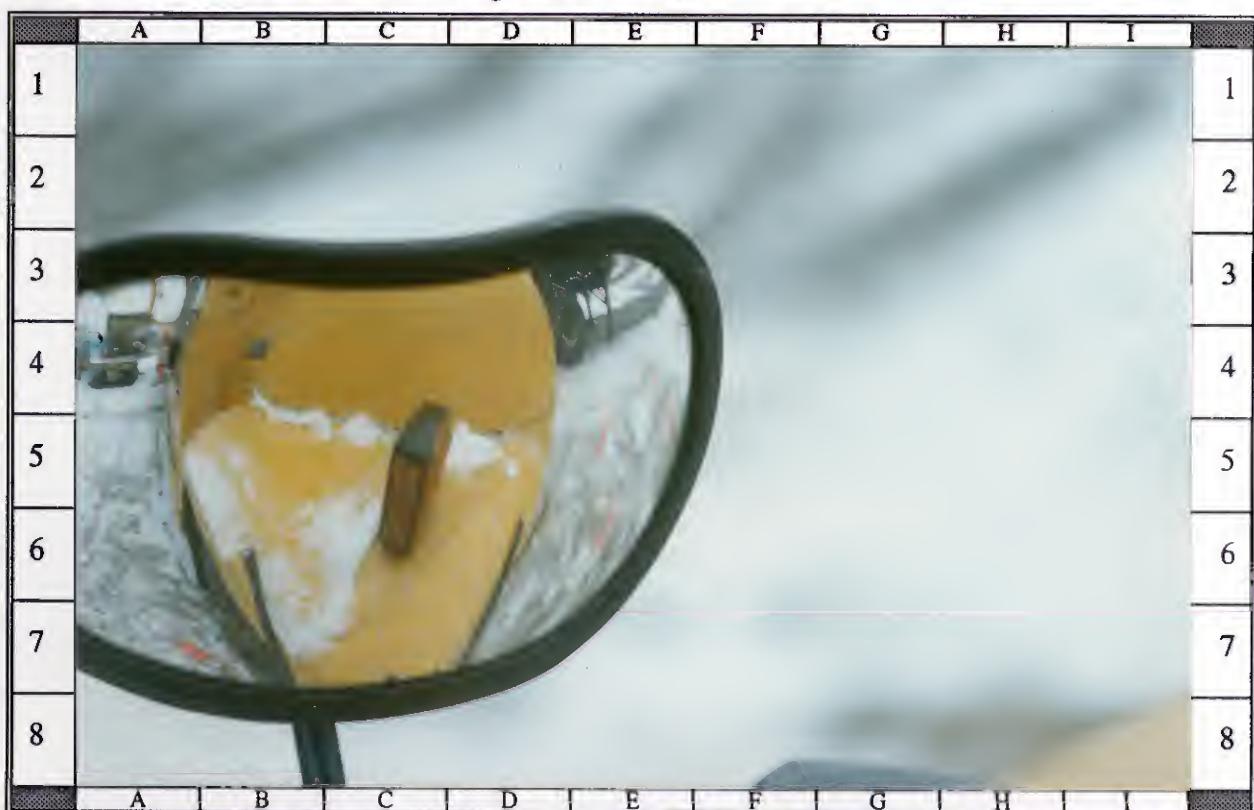
# 32: Telephoto view from Case Vehicle's driver seat through left, outside, convex, crossview mirror focusing across front

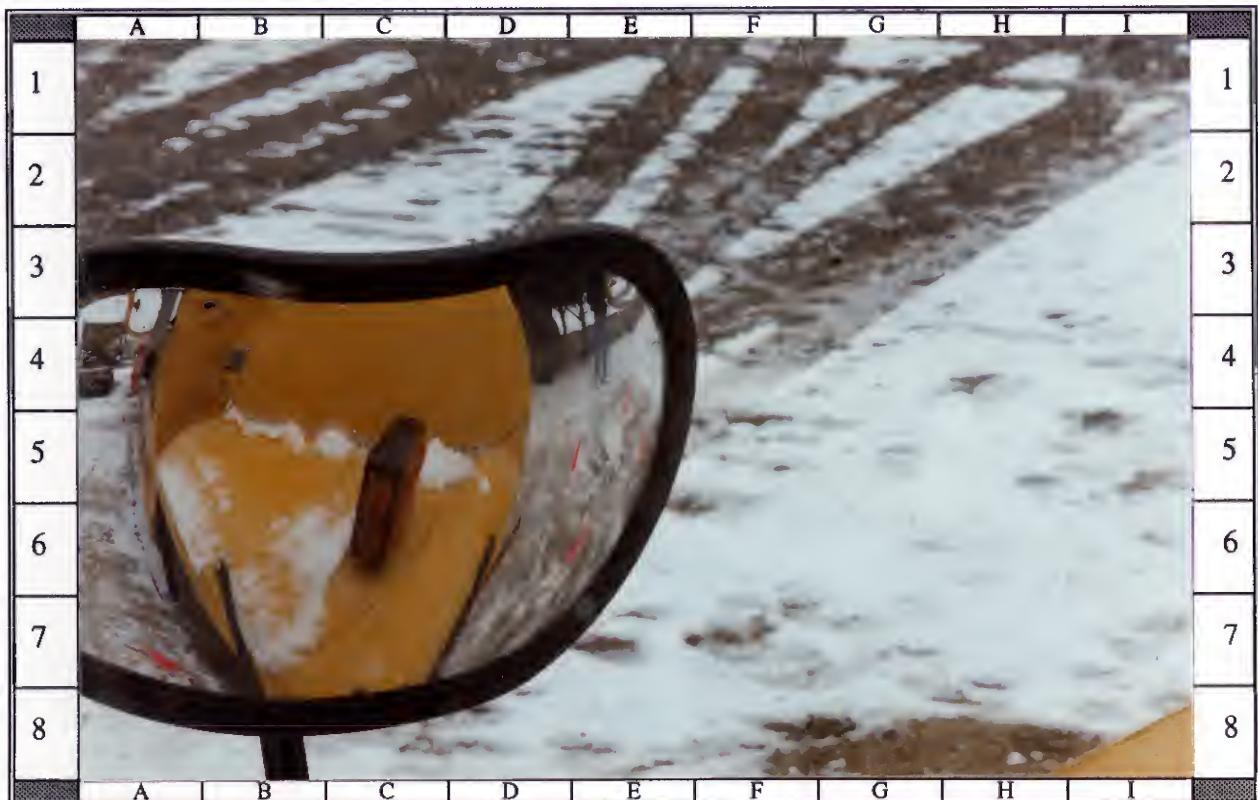
# 33: Telephoto view from Case Vehicle's driver seat through left, outside, convex, crossview mirror pointing to cone C and showing cones F, B, and E

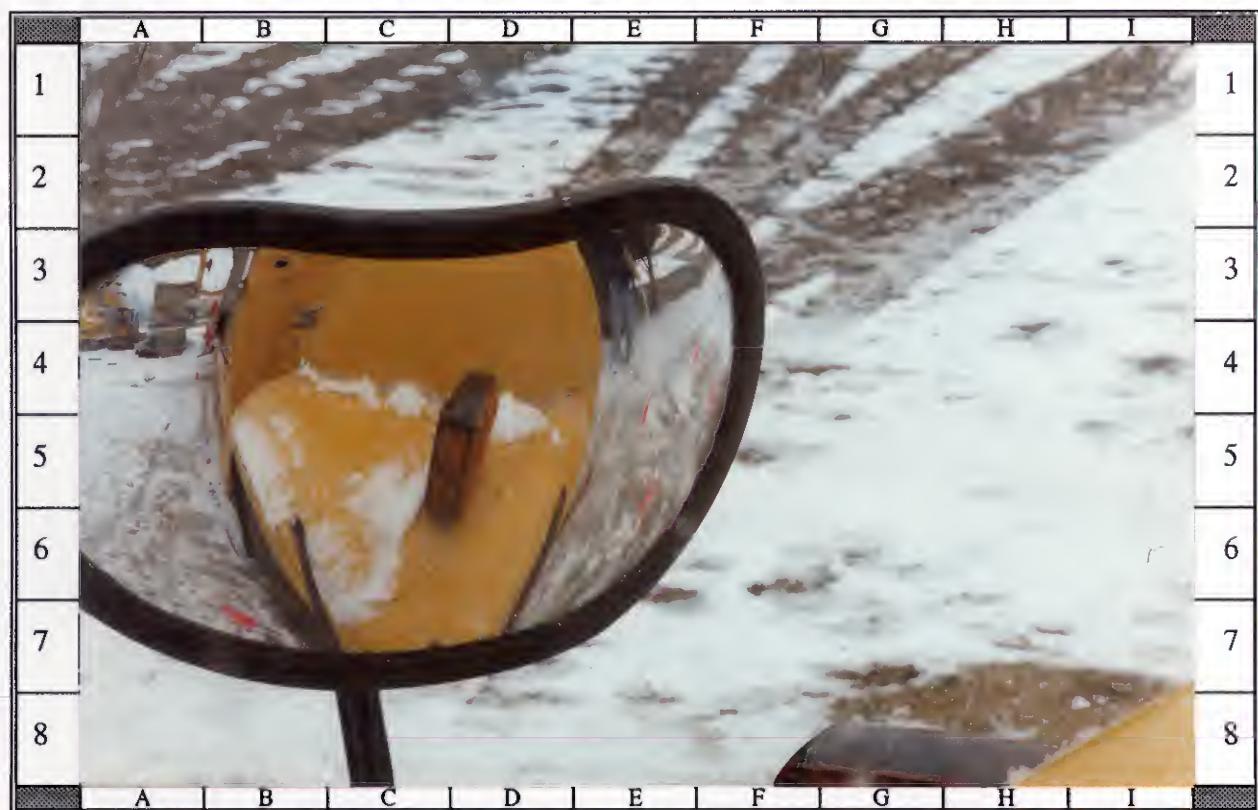
# 34: Telephoto view from Case Vehicle's driver seat through left, outside, convex, crossview mirror pointing to cone F and showing cones C, B, and E

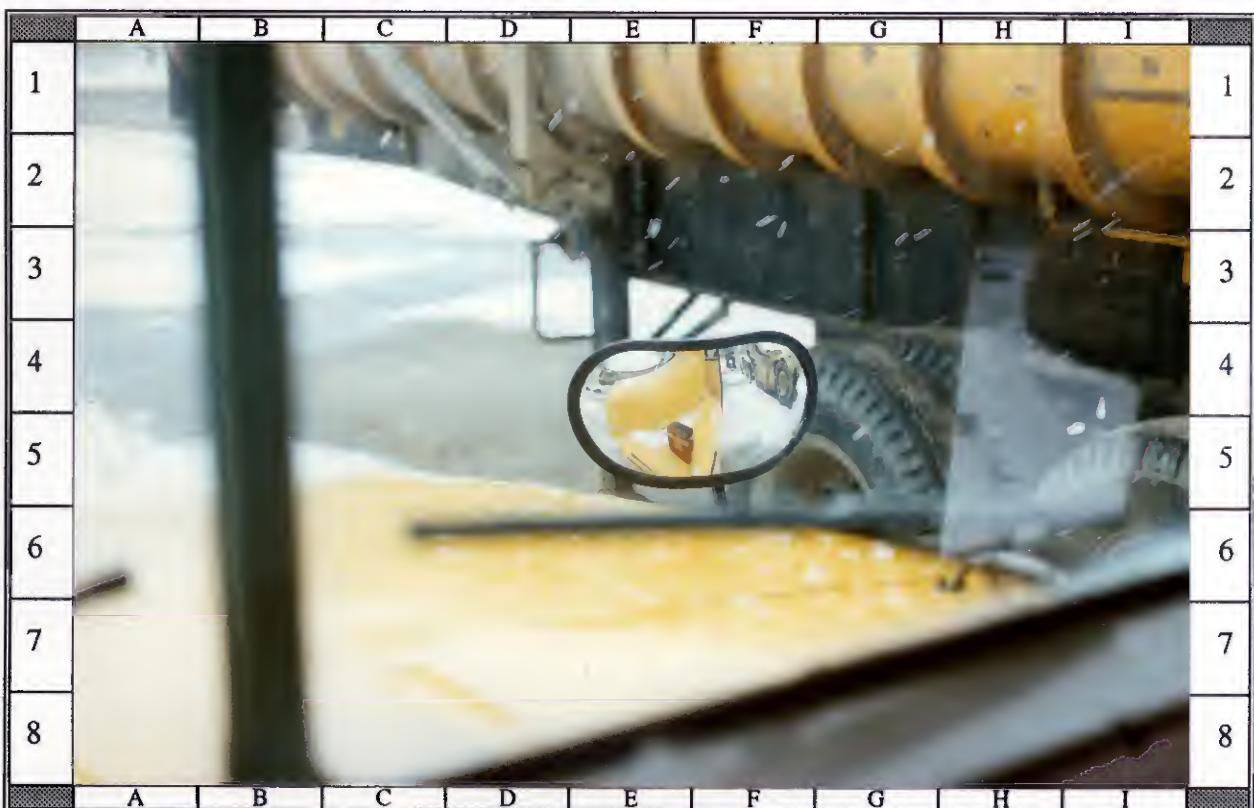
# 36: Normal view from Case Vehicle's driver seat through right, outside, convex, crossview mirror; NOTE: viewer raised up above windshield wiper

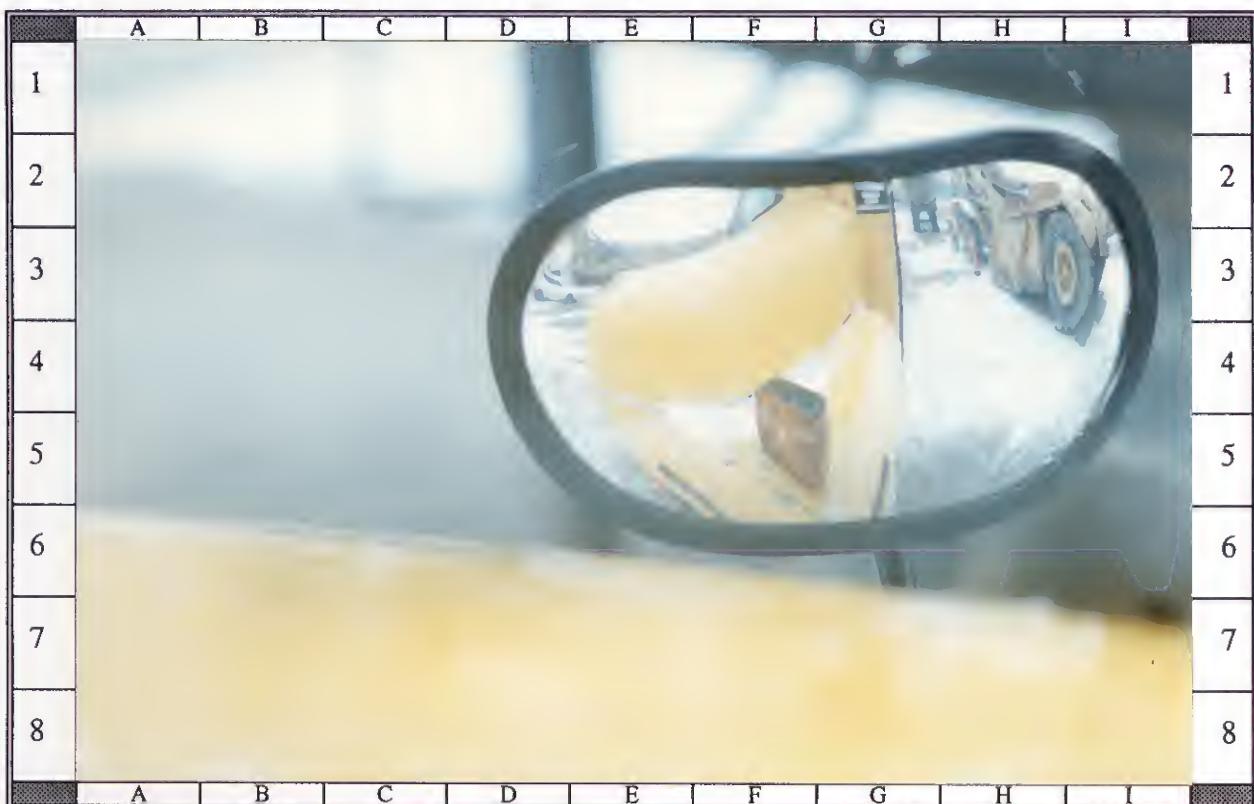
# 37: Telephoto view from Case Vehicle's driver seat through right, outside, convex, crossview mirror focusing across front; NOTE: only cone H visible

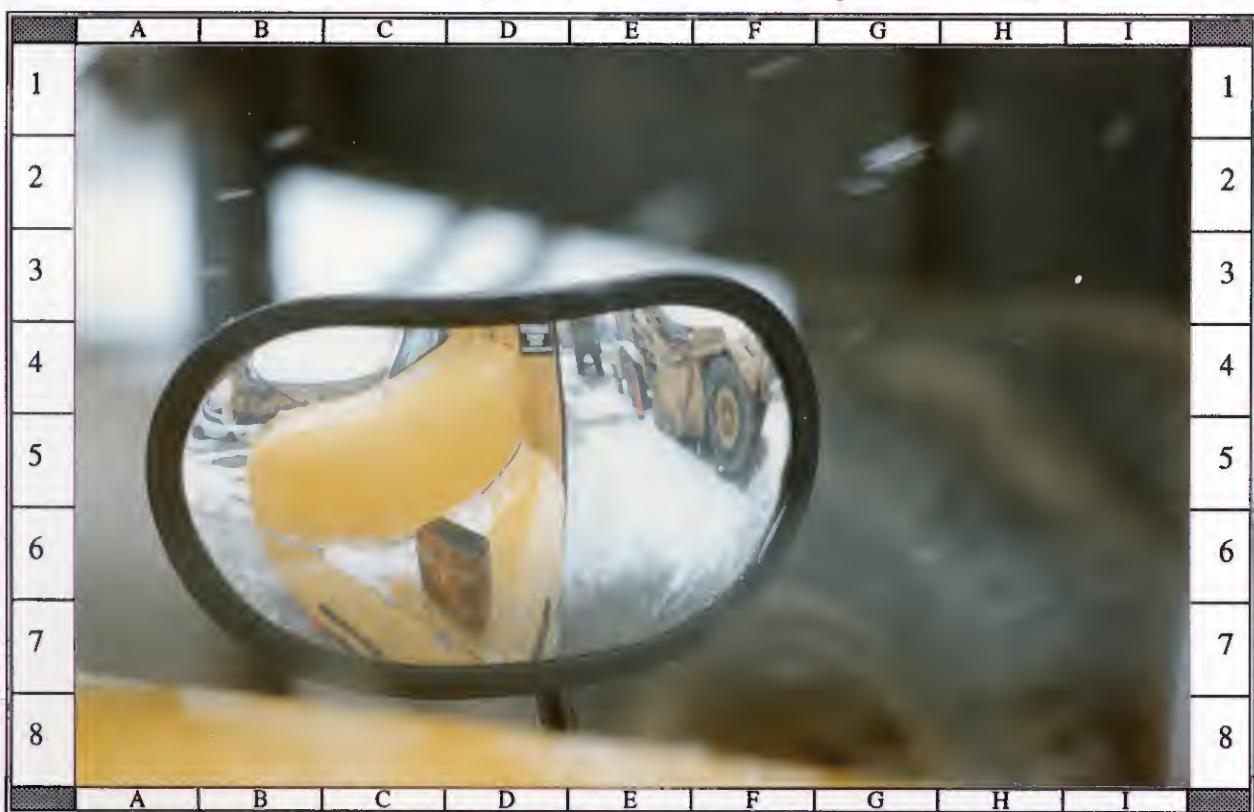
# 38: Telephoto view from Case Vehicle's driver seat through right, outside, convex, crossview mirror focusing down right side showing cones O and P

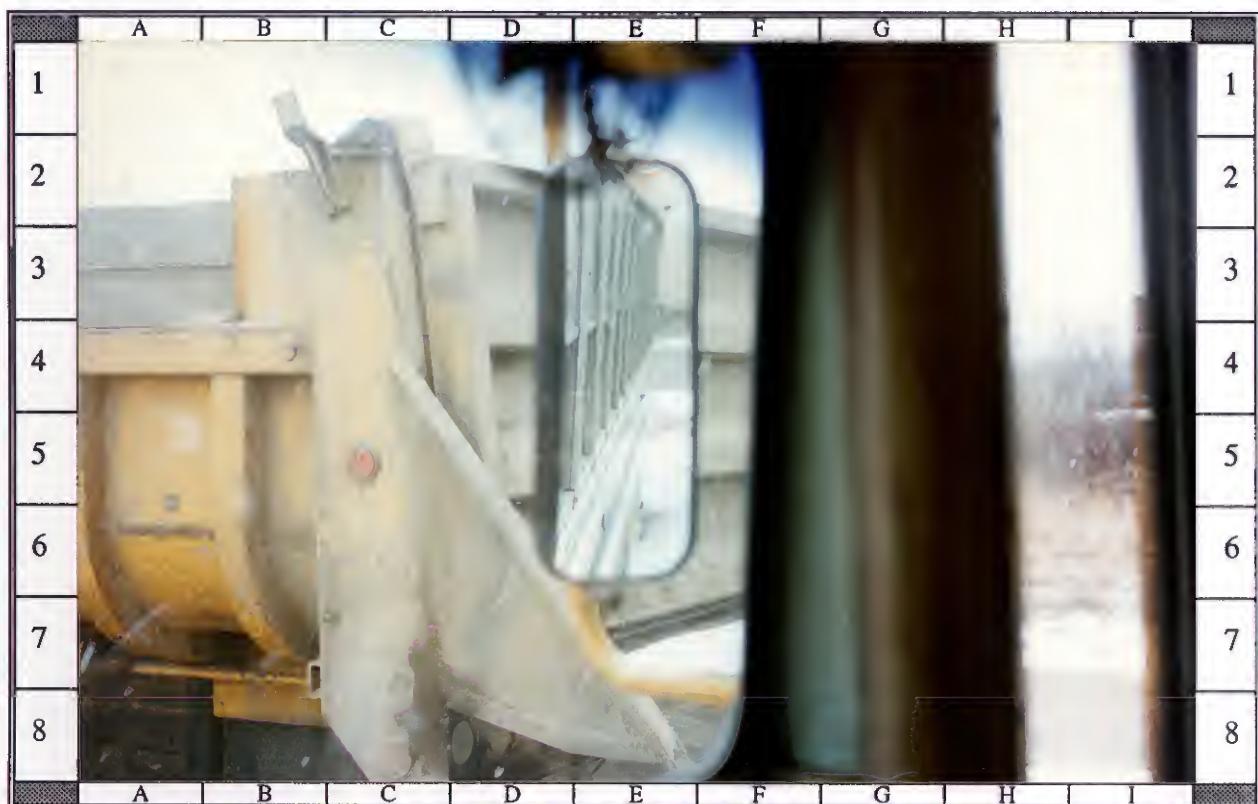
# 39: Normal view from Case Vehicle's driver seat through right, outside, unit magnification mirror; NOTE: no test cones are visible

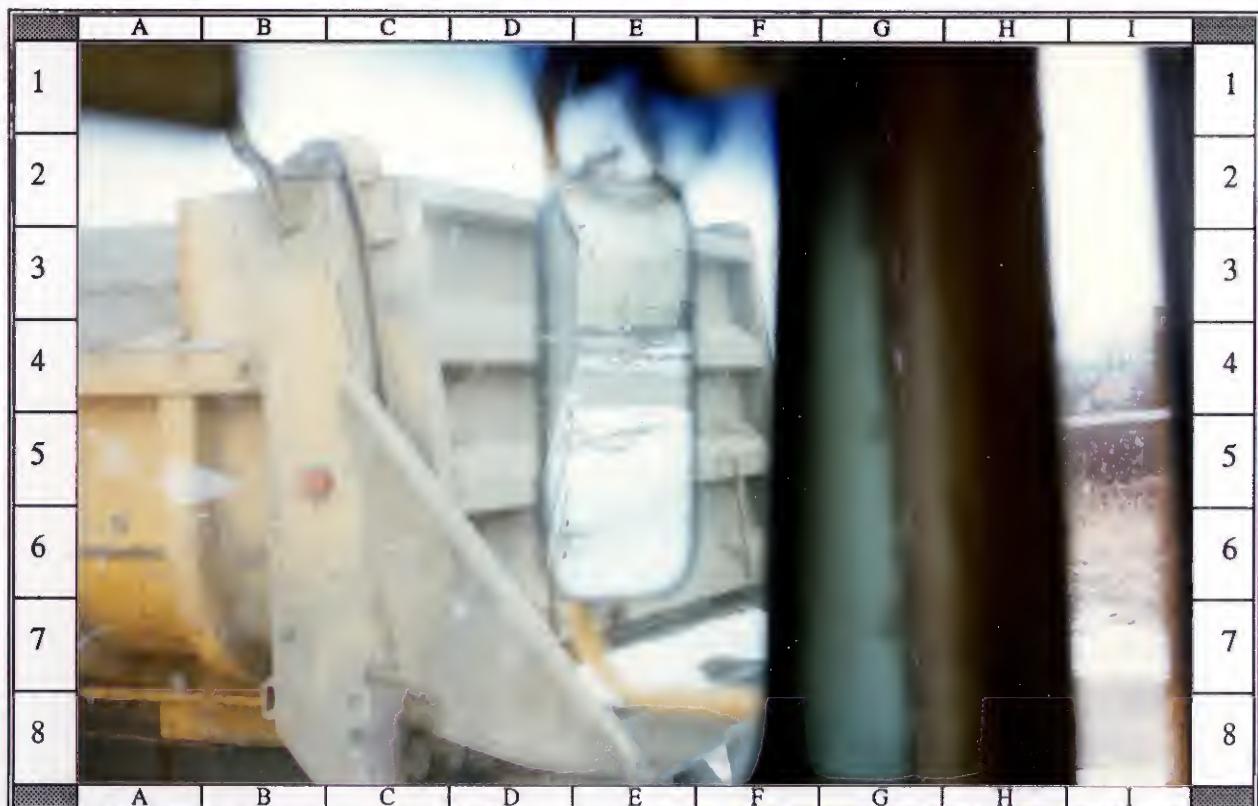
# 40: Normal view from Case Vehicle's driver seat through right, outside, unit magnification mirror after viewer moves forward; NOTE: no visible test cones
